SITE & BUILDING CONSTRUCTION EVALUATION

Section 1 Site Access

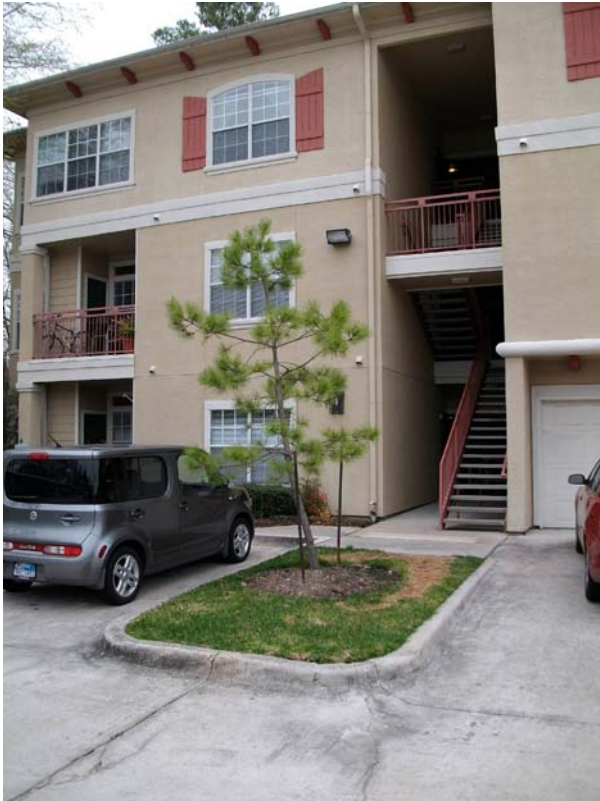
Bldg 12, Left Breezeway Entry (#S0047)

The left breezeway had a short sidewalk that connected with a blended transition to a parking space behind the garages on one side, and to a curb at another parking space on the other side. There was no detectable warning at the blended transition to the right parking space and no curb ramp to the parking on the left.

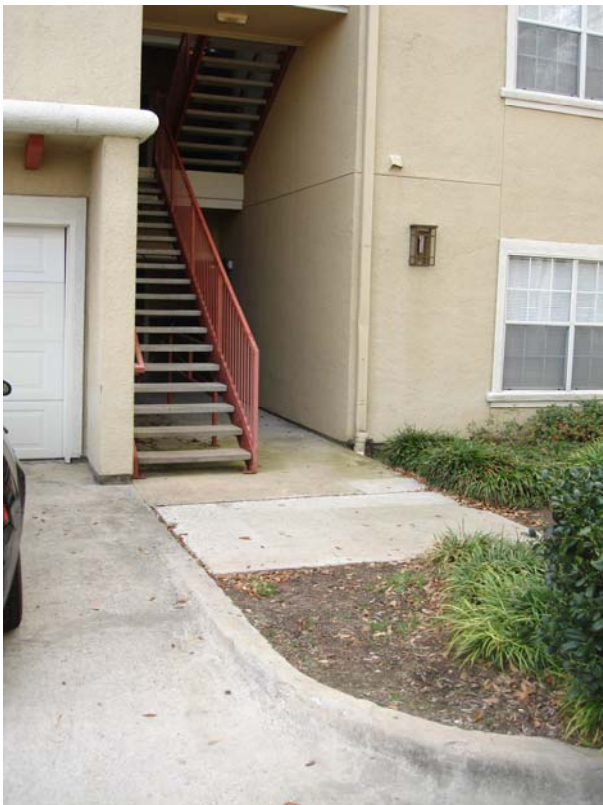
Bldg 13, Right Breezeway Entry (#0349)

The right breezeway had a short sidewalk that ended at a blended transition to a parking space behind the garages. There was no detectable warning at the blended transition to the parking space.

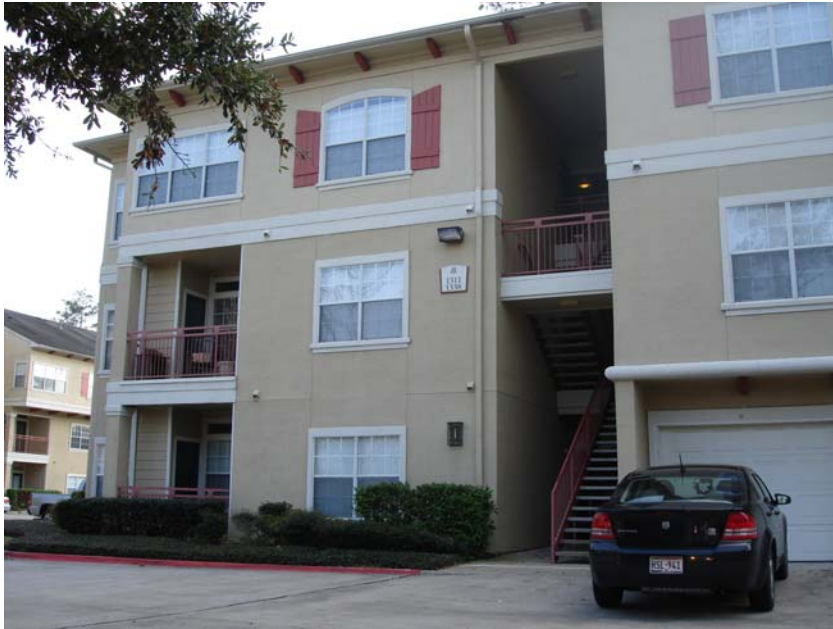
*Bldg 13, Left Breezeway
Entry (#0337)*

The left breezeway ended in a blended transition to concrete paving at a parking space and the vehicular lane.

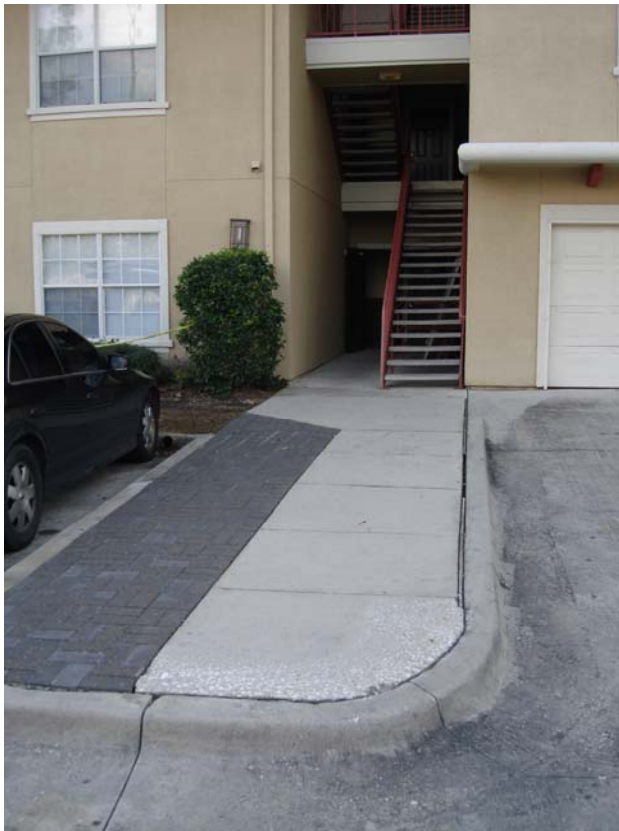
Bldg 14, Right Breezeway (#0300)

The right breezeway had a sidewalk that extended straight out to the drive lane and a curb. At one side, the walk ended at a parking space behind the garages. There was no detectable warning at the blended transition to the parking space nor was there a curb ramp or detectable warning at the curb at the vehicular lane.

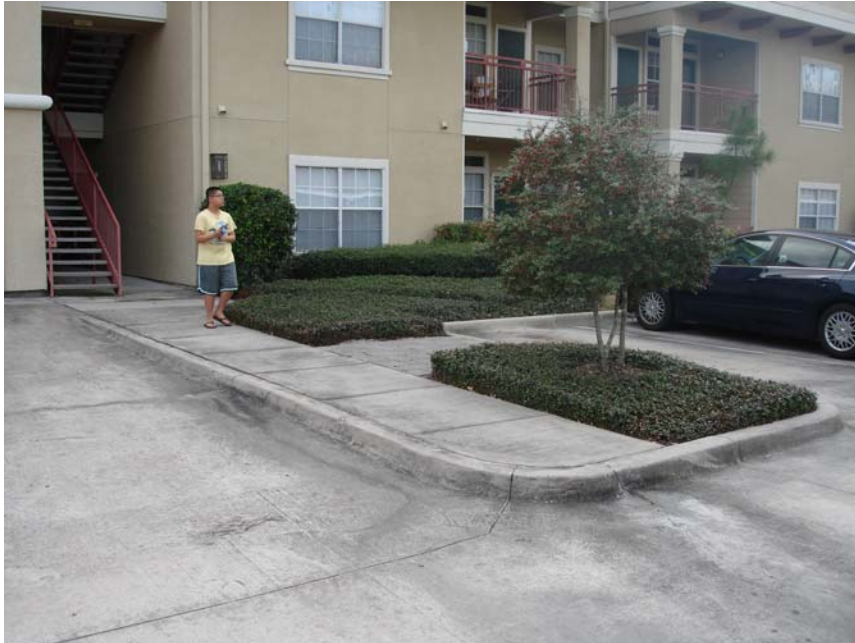
Bldg 14, Left Breezeway Entry (#0270)

The left breezeway had a sidewalk that extended straight out to the drive lane and a curb. At one side, the walk led to open a parking space behind the garages, at the other a short walk led to a curb and another parking space. There was no detectable warning at the blended transition to the parking space nor was there a curb ramp or detectable warning at the curb at the vehicular lane or the right parking space.

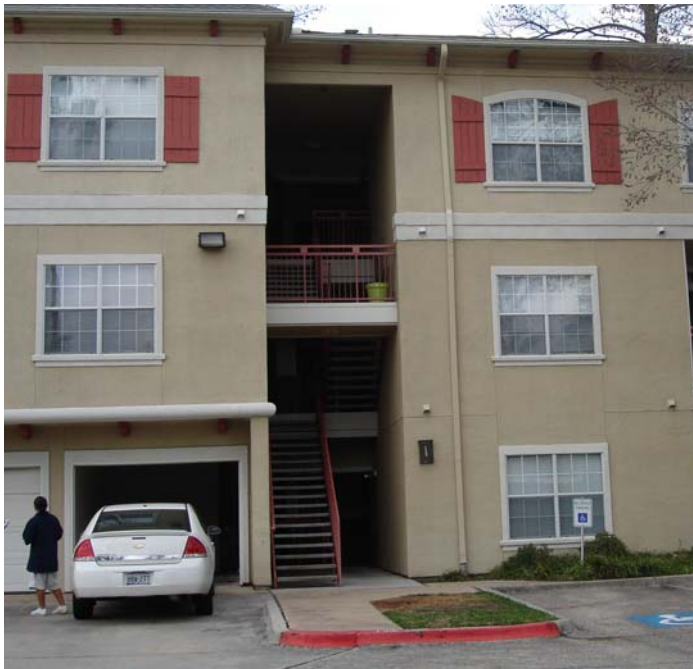
Bldg 15 Right Breezeway Entry (#0186)

The right breezeway had a sidewalk that extended straight out to the drive lane and a curb. At one side, the walk led to a parking space behind the garages, at the other a short walk led to a curb and another parking space. There was no detectable warning at the blended transition to the parking space nor was there a curb ramp or detectable warning at the curb at the vehicular lane or the right parking space.

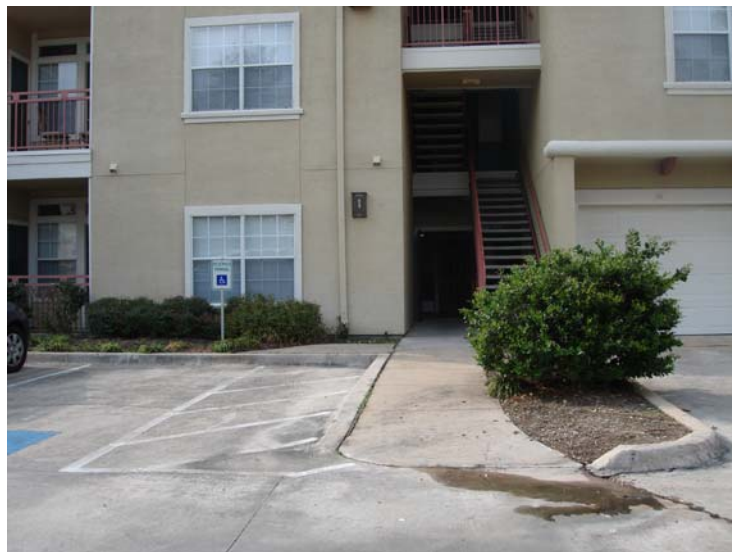
Bldg 15, Left Breezeway (#0189)

The left breezeway had a sidewalk extended straight out to the drive lane. At the left side, the walk was adjacent to the access aisle of an accessible parking space. There was no detectable warning at the curb ramp to the parking space and vehicular lane. The cross slope at the base of the curb ramp was 3.6%, more than the 2% permitted (ANSI 4.3.7).

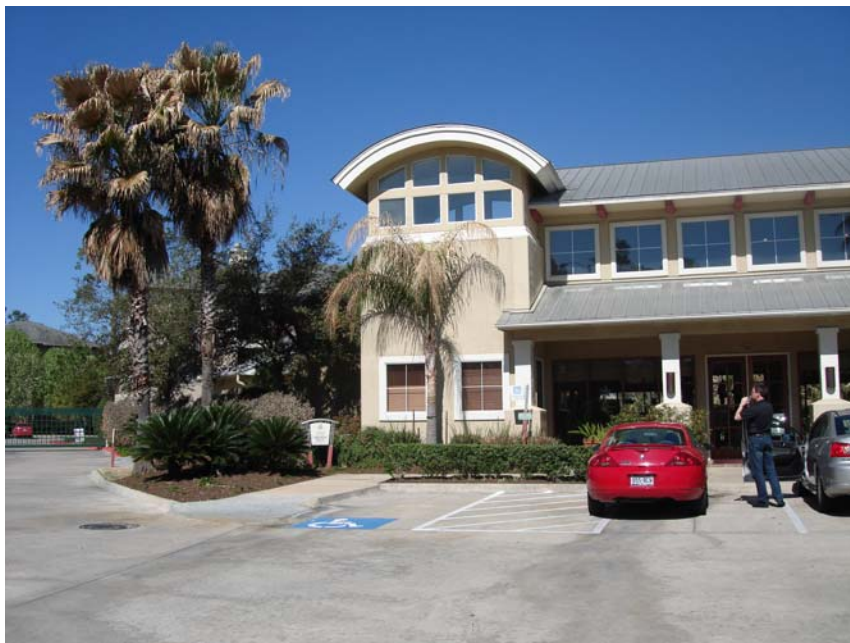
*Parking at Leasing Office
(#0941)*

One space was provided adjacent to the entry of the leasing office. It was designated as van accessible and striped accordingly.

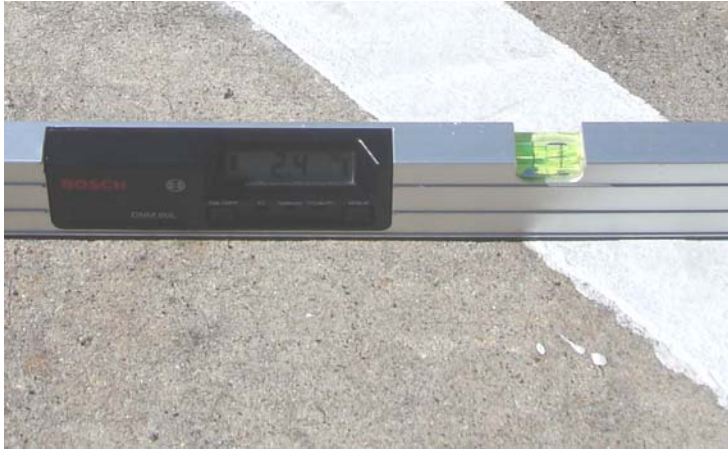
Level at Leasing Office Space (#0936)

A portion of the access aisle did not comply with the maximum 2% cross slope requirement (2.3%). “Parking spaces and access aisles shall be level with surface slopes not exceeding 1:50 (2%) in all directions.” (ADA Std. 4.6.3, ANSI 4.3.7). The curb ramp and sidewalk to the leasing office from this space was not accessible (see Page 1-1).

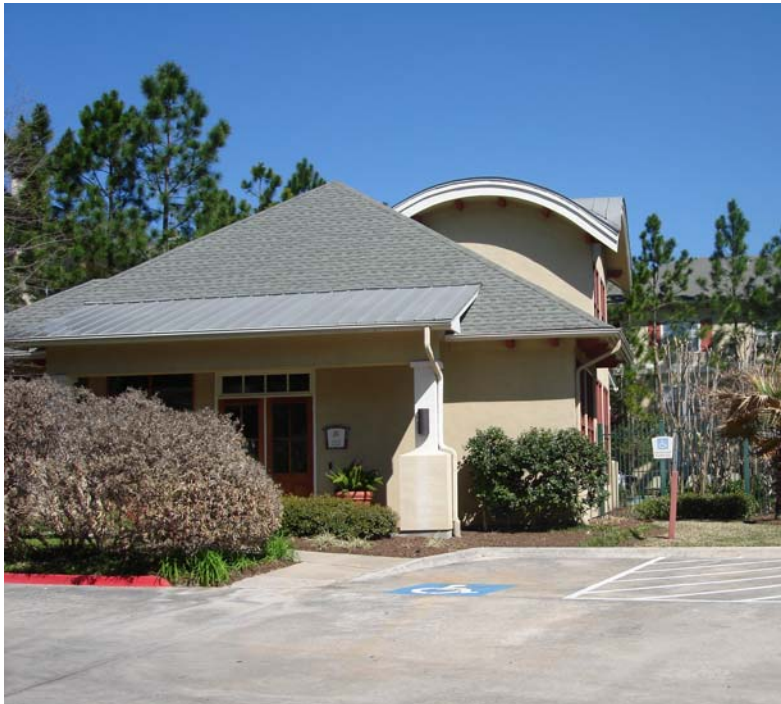
Parking at Game Room (#0950)

A portion of the access aisle did not comply with the maximum 2% slope requirement (2.1%). “Parking spaces and access aisles shall be level with surface slopes not exceeding 1:50 (2%) in all directions.” (ADA Std. 4.6.3, ANSI 4.3.7). The curb ramp and sidewalk to the leasing office from this space was not accessible (see Page 1-1).

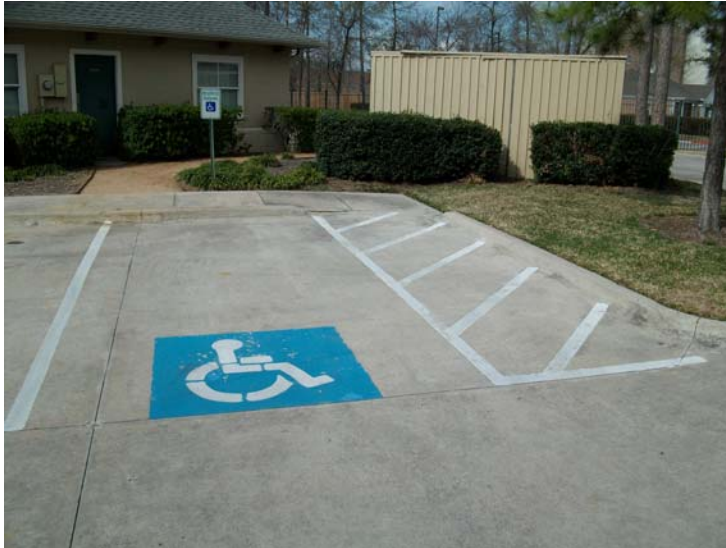
Parking at Mail Building (#S0339)

No route was provided from parking to the building (see description, page C-1-13). The sign for the space was not mounted high enough to be visible beyond a vehicle parked in the space (ANSI 4.6.2).

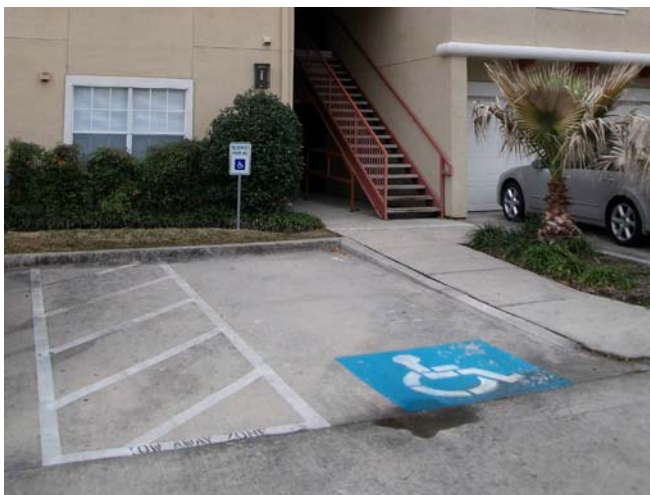
*Parking at Building 10 (#S0017)
Sign at Parking Space (#S0029)*

The sign for the space was not mounted high enough to be visible beyond a vehicle parked in the space (ANSI 4.6.2). No accessible route is provided to the building. To reach the curb ramp, the person using the aisle must pass into the vehicular way and cross behind their vehicle to the bottom of the ramp. The ramp itself was not accessible (see Building 10 Entry).

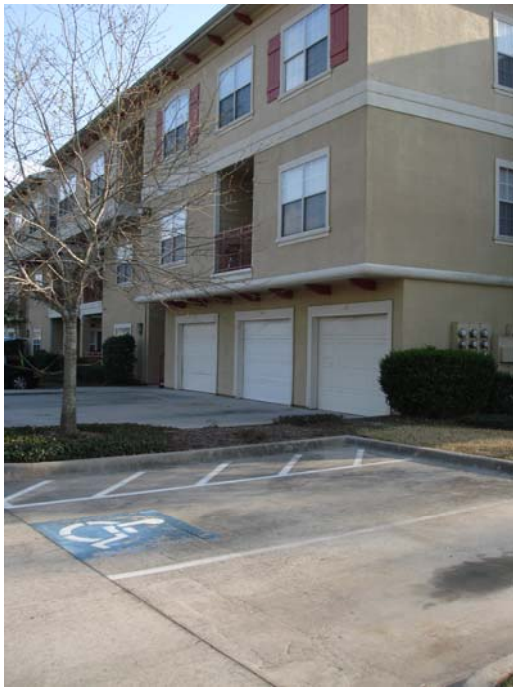
*Accessible space by Bldg 14 (#0330)
Sign at Bldg 14 Space (#0331)*

There was one accessible space by this building. The sign for the space was not mounted high enough to be visible above and beyond a vehicle parked in the space (ANSI 4.6.2). No accessible route was provided from the parking space to any building entry.

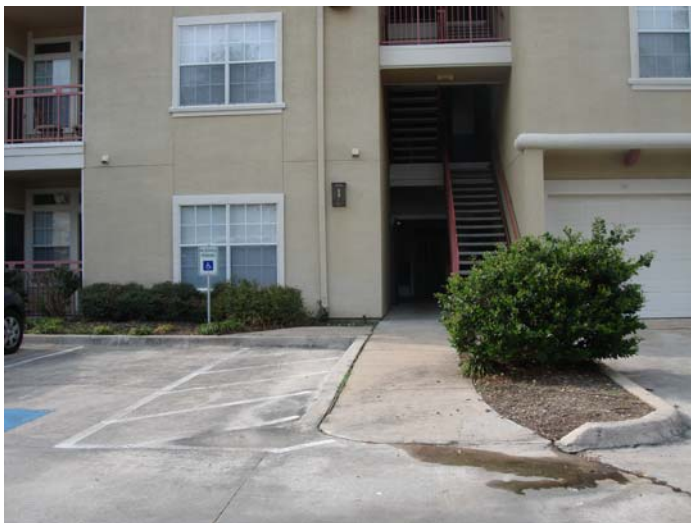
*Accessible space at Bldg 15 (#0189)
Sign at Bldg 15 Space (#0221)*

There was one accessible space by this building. The sign for the space was not mounted high enough to be visible over a vehicle parked in the space (ANSI 4.6.2). No accessible route was provided from the parking space to any building entry.
